ROYAL AIRCRAFT ESTABLISHMENT
(FARNBOROUGH)

TECHNICAL NOTE No: MECH. ENG. 333

CONTINUOUS-ROD WARHEAD
LETHALITY TRIALS AGAINST
B.29 AIRCRAFT FUSELAGES

(3/16, 1/4 and 5/16 INCH SQUARE-SECTION RODS)

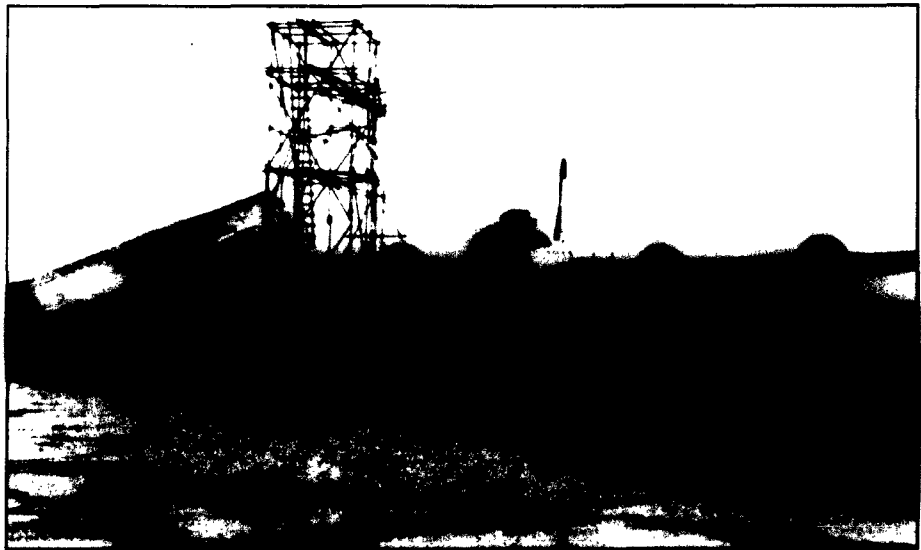
FIG.10. TYPICAL LAYOUT SHOWING PRIMARY
AND SECONDARY TARGETS (FIRING 4)

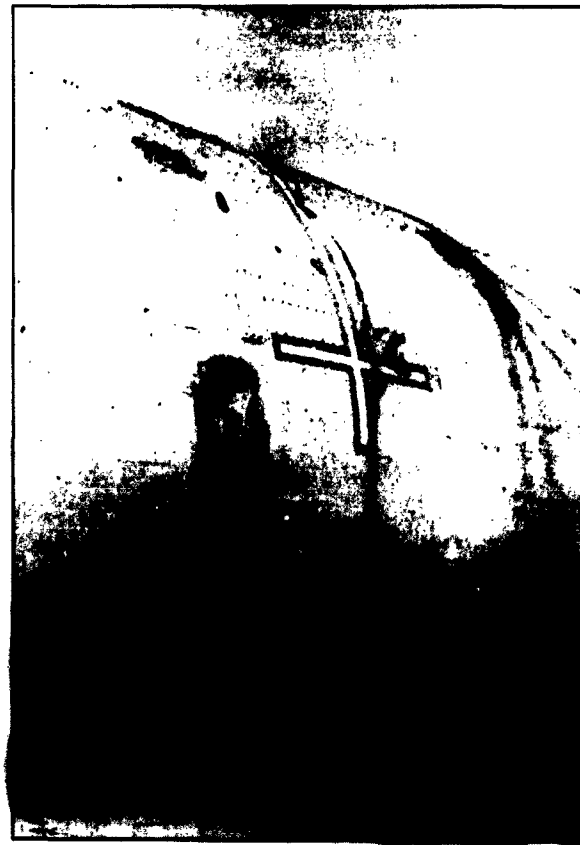
FIG.11d. FIRING I. SECONDARY TARGET. VICTOR REAR FUSELAGE
AFTER FIRING ($\frac{1}{4}$ inch ROD. STN.900)

9.2.3 The low percentage (31%) of structure severed by the 1/4 in. rod when attacking the Victor rear fuselage was due to the presence of strong structural members located near the fuselage centre line which the rod was unable to damage severely, having already passed through the fuselage skin.

(g) Damage to the 'Victor' target showed that a 1/4 in. rod is capable of severing typical sandwich skin structure comprising longerons, double skin and closely spaced stringers and that exit side damage is small when internal diaphragms are present.
